# Inspection Report

**Property Address:**  
366 Broadway  
New York, NY 10013

### Precise Home Inspection Services

<b>Date:</b> 1/4/2011	<b>Time:</b> 10:15 AM	<b>Report ID:</b>
<b>Property:</b> 366 Broadway New York, NY 10013	<b>Customer:</b> Actual Sample Report	<b>Real Estate Professional:</b>

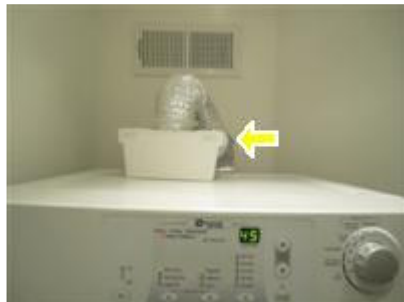
There was no means to vent the dryer to the exterior of the building. Either an apartment dryer vent kit is needed, as the one in place at the time of inspection, or a ventless type dryer. Apartment dryer vent kits will require frequent maintenance to prevent lint and moisture from becoming an issue.

1.16 Picture 1 dryer vent kit

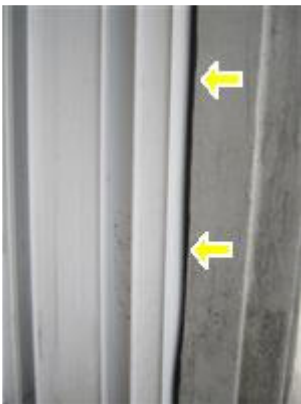
2.5.A Picture 1

The exterior frame(s) of the windows did not have sealant where it meets the exterior of the home. Sealant is recommended to prevent air, moisture and insects from entering. Repair as needed.

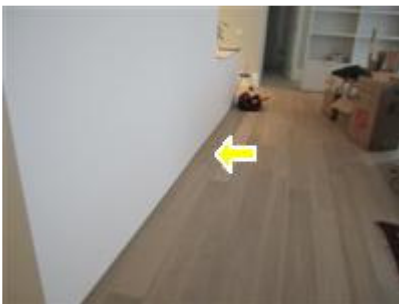
There was not a sufficient number of wall receptacles to meet today's standards. For instance, there should be a wall receptacle on each permanent wall that is greater than 2' wide, receptacles should not be spaced greater than 12' and receptacles should be no more than 6' from end of a wall. See diagram.

2.6.A Picture 1 living room - no wall receptacles on this wall

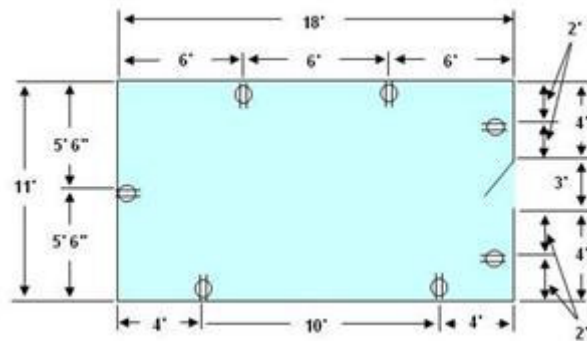
2.6.A Picture 2 Required receptacle locations

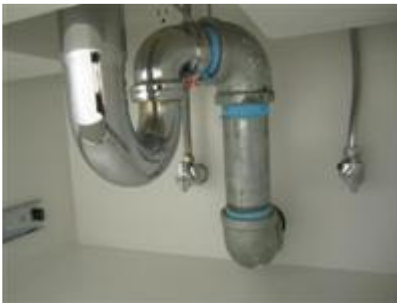
The drain trap below the sink is considered an "S" trap configuration because it does not have a vertical section after the trap which is 2 X the width of the pipe. An approved "P" trap configuration is recommended. An "S" trap can allow water to be drained from the trap. The trap should be able to hold water to create a seal against sewer gases from entering the home. I recommend further evaluation and repair as needed by a licensed plumber.

3.3.A Picture 1 S trap - hall bath

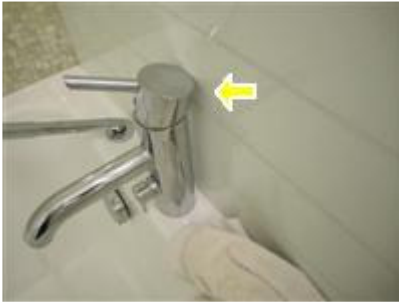
3.4.B Picture 1

(1) The tub faucet handle appeared to be restricted from opening to its fullest position because it is interfered with by the wall. Restricted flow and operation can result. Correct as needed or desired.

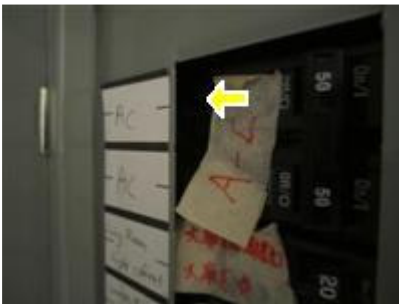
The electrical service panel has wide spacing between the circuit breakers and the dead front cover. There should be no openings in the panel cover which can allow contact with the interior of the electrical panel. This is an electrical shock and safety issue that should be corrected. A qualified electrician should evaluate and correct as needed.

5.1 Picture 1 wide space - safety issue

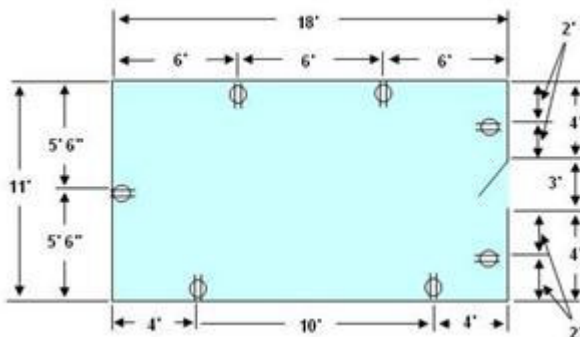
5.3 Picture 1

There was not a sufficient number of wall receptacles in several areas to meet today's standards. For instance, there should be a wall receptacle on each permanent wall that is greater than 2' wide, receptacles should not be spaced greater than 12' and receptacles should be no more than 6' from end of a wall. See diagram.

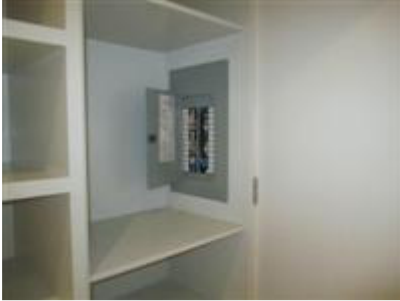
The location of the electrical distribution panel (in the Study) does not meet the recommended accessibility clearance requirements. There should be a minimum of 36" clearance in front, and 30" wide clearance.

5.6 Picture 1 does not meet access clearance requirements

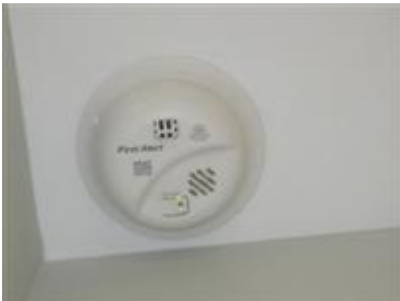
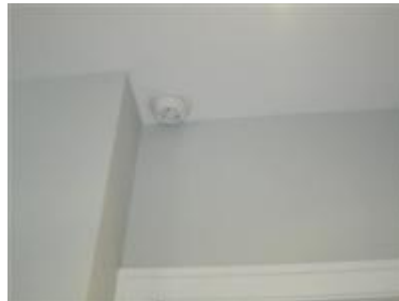
- 🏠 The apartment does not have any smoke detectors installed. It appeared that in lieu of smoke detectors there are heat detectors installed. Heat detectors do not detect smoke and are generally used where standard smoke alarms are not suitable. For instance, kitchens, unfinished attics, boiler rooms, basements, attics, garages. While the heat detectors are a useful component in a fire alarm system when installed as intended, they do not preclude the use of smoke detectors in recommended locations. Current standards require, and the National Fire Protection Agency (NFPA) recommends, the installation of smoke alarms in each separate sleeping room, outside each sleeping room in the immediate vicinity of the bedroom, on each additional story of the dwelling unit. It is recommended that smoke alarms be installed where needed. It is also recommended that the location of the smoke alarms be installed in a location that are not considered "dead air" spaces which may prevent smoke from reaching the alarm. For instance, smoke detectors installed on the ceiling should be installed as close to the center of the ceiling as possible, if not possible they should be installed at least 4 inches away from the wall or corner.

5.7 Picture 1 Heat Alarm - hall area near 2nd bedroom 5.7 Picture 2 dead air space location - not recommended

The apartment does not have any smoke detectors installed. It appeared that in lieu of smoke detectors there are heat detectors installed. Heat detectors do not detect smoke and are generally used where standard smoke alarms are not suitable. For instance, kitchens, unfinished attics, boiler rooms, basements, attics, garages. While the heat detectors are a useful component in a fire alarm system when installed as intended, they do not preclude the use of smoke detectors in recommended locations. Current standards require, and the National Fire Protection Agency (NFPA) recommends, the installation of smoke alarms in each separate sleeping room, outside each sleeping room in the immediate vicinity of the bedroom, on each additional story of the dwelling unit. It is recommended that smoke alarms be installed where needed. It is also recommended that the location of the smoke alarms be installed in a location that are not considered "dead air" spaces which may prevent smoke from reaching the alarm. For instance, smoke detectors installed on the ceiling should be installed as close to the center of the ceiling as possible, if not possible they should be installed at least 4 inches away from the wall or corner.

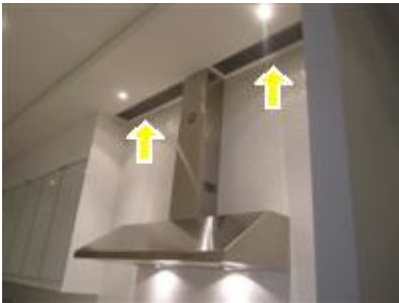
6.3 Picture 1

Per the owner, one of the vent covers at the side of the range hood is the return vent for the air conditioning system - although I did not confirm this. Return vents for central forced air heating or cooling systems are not allowed to be located in kitchens, bathrooms, garage or furnace room or closet. Additionally, the vent is in very close proximity to the kitchen range hood exhaust and the exhaust can be distributed throughout the AC system. This is an improper installation which should be corrected.
